PHASE I ENVIRONMENTAL PROPERTY ASSESSMENT

2325 Wisconsin Street
Downers Grove, Illinois

EPS Environmental Services, Inc.
7237 West Devon Avenue
Chicago, Illinois 60631

November 1, 2001

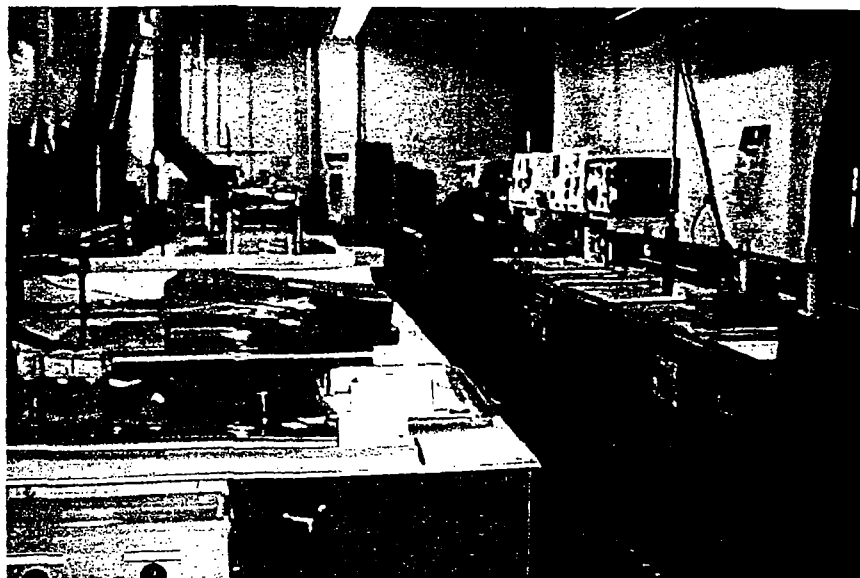
A designated hazardous material storage area is located in the addition portion of the structure. The room contains 55-gallon storage drums of alkaline solvents and 100-gallon containers of various plating solutions and rinse tanks. The dip tanks contain alkaline solutions, water rinses, PCE, and cyanide solutions for zinc, gold, silver and copper plating baths. No leaks were observed and no significant cracks in the concrete surface below the storage drums, containers or tanks were noted.

**Right: Hazardous Materials
Room. 100-gallon dip tanks**

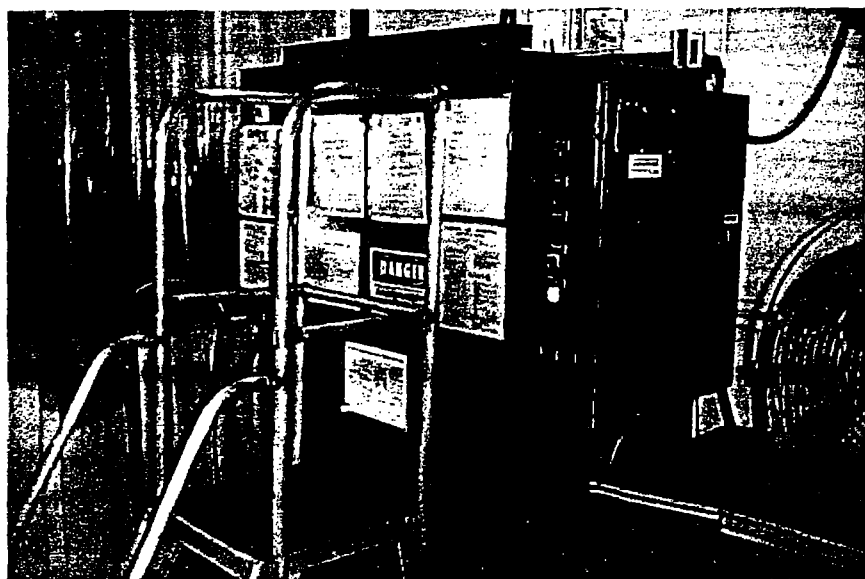
A solvent odor was noted in the hazardous materials room, emanating from the vapor-degreasing machine.

A vapor degreaser is located in the hazardous materials room. This equipment utilizes PCE as a solvent.

**Below: Vapor Degreaser (located
in the Hazardous Materials
Room). It should be noted that
this equipment contains PCE.**

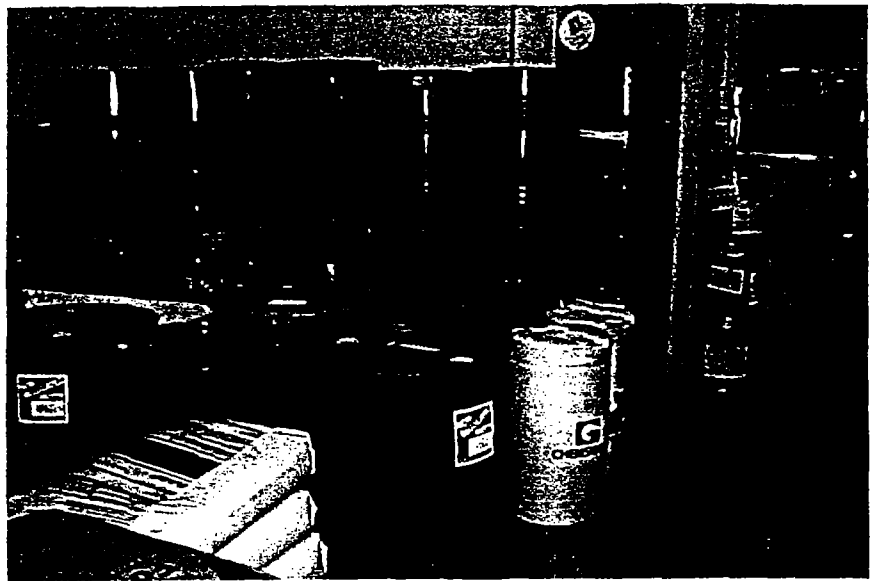
**Right: 55 gallon drums stored in
receiving area**
